# CuBe 5 kbar prototype

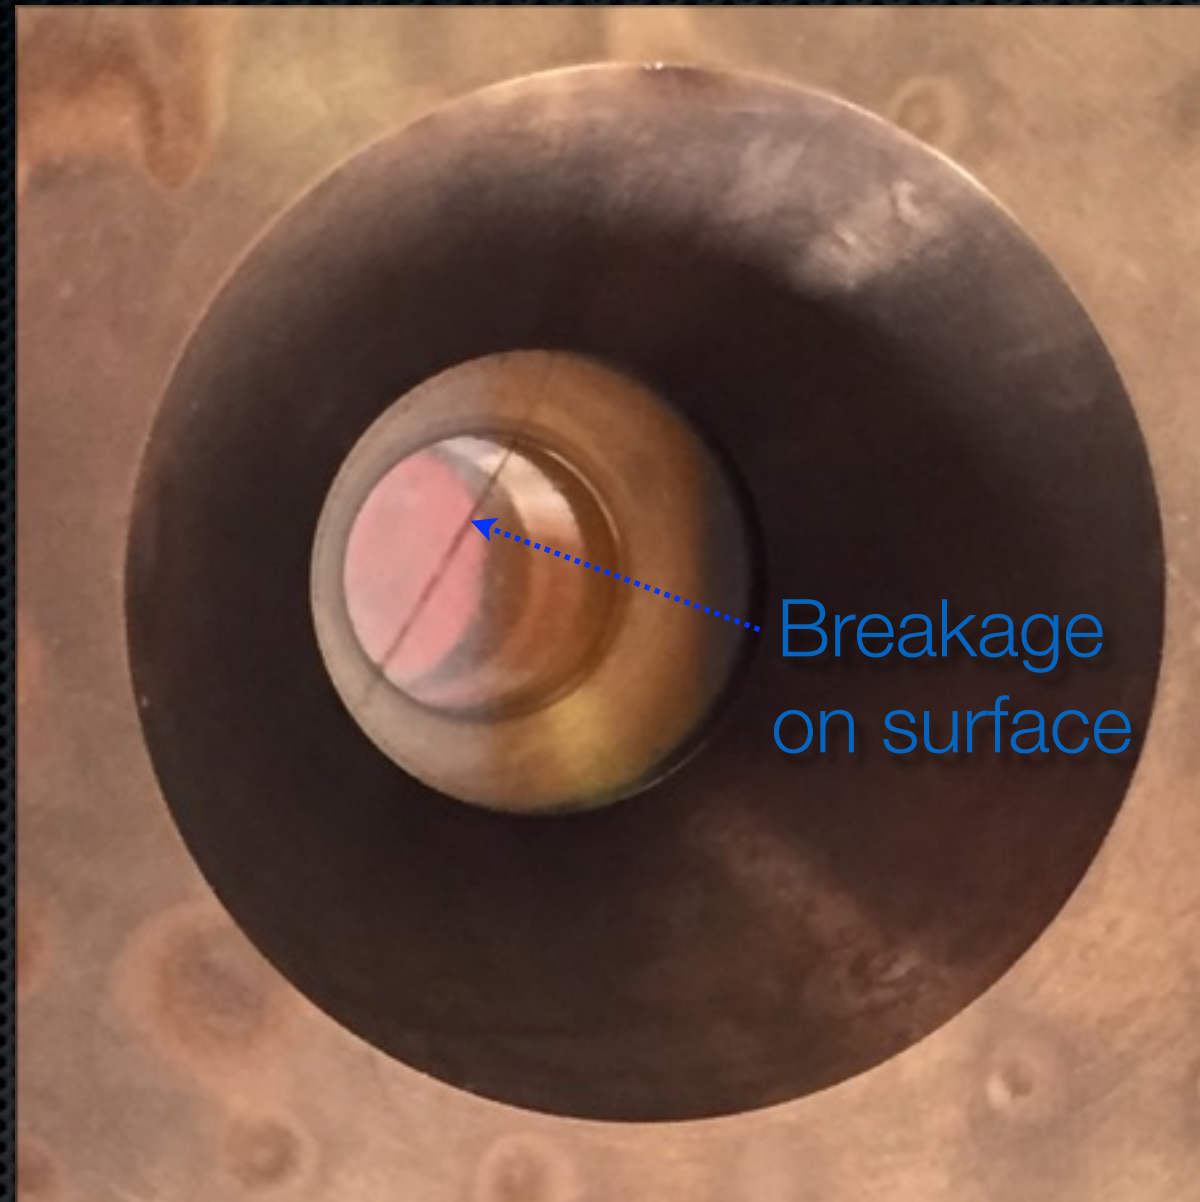
Several steps (12 hours) up to 5 kbar

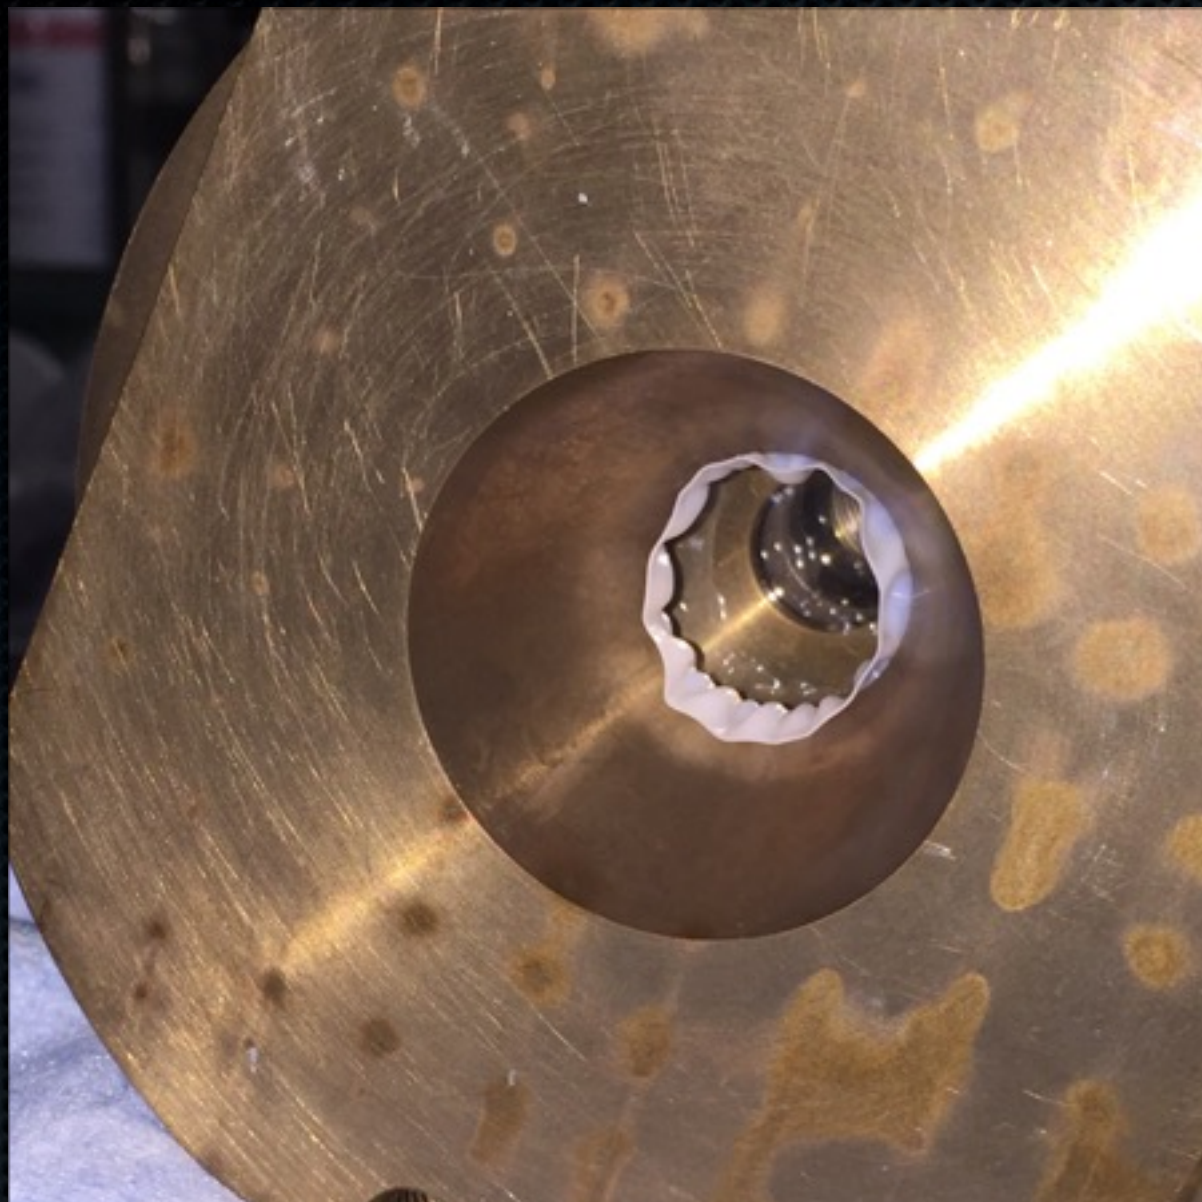
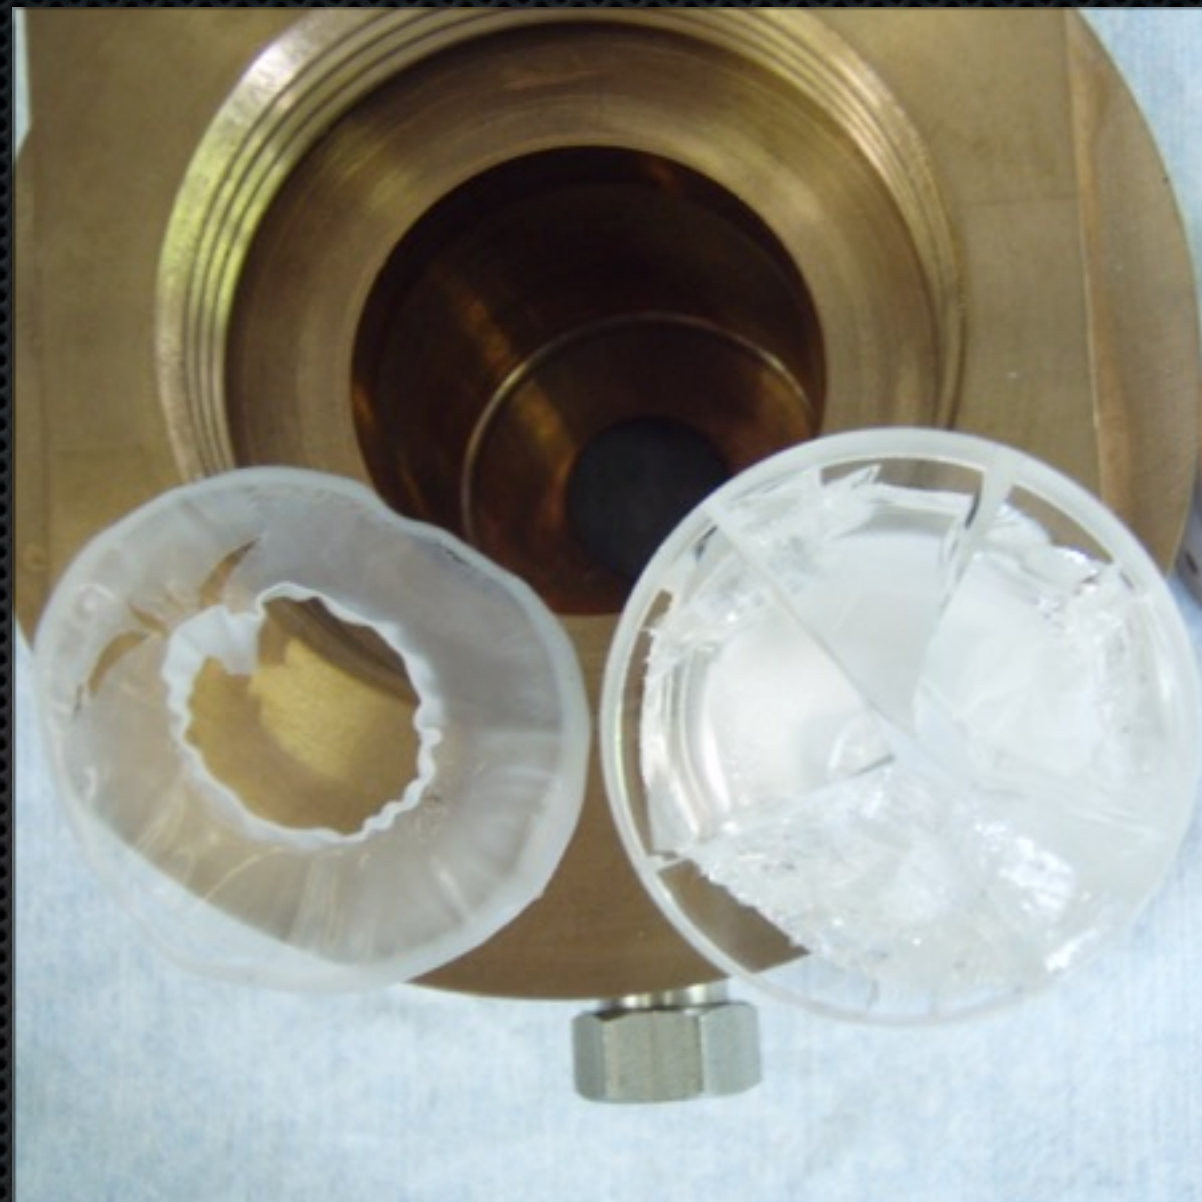
# Sapphire window breakage

@ 5 kbar after a night under pressure

Teflon seal (0.2 mm thickness)

- ✦ Pressure tests @ 2 kbar successfull!
- ✦ Re-machine the body (support + fluid circuit)
- ✦ Scheduled experiments on D11 in June & July
- ✦ Reduce the incident window displacement (1 - 2.7 mm)
